Reconciling Design Intent with Real World Existing Conditions

BY JOHN M. **RUSSO**, AIA

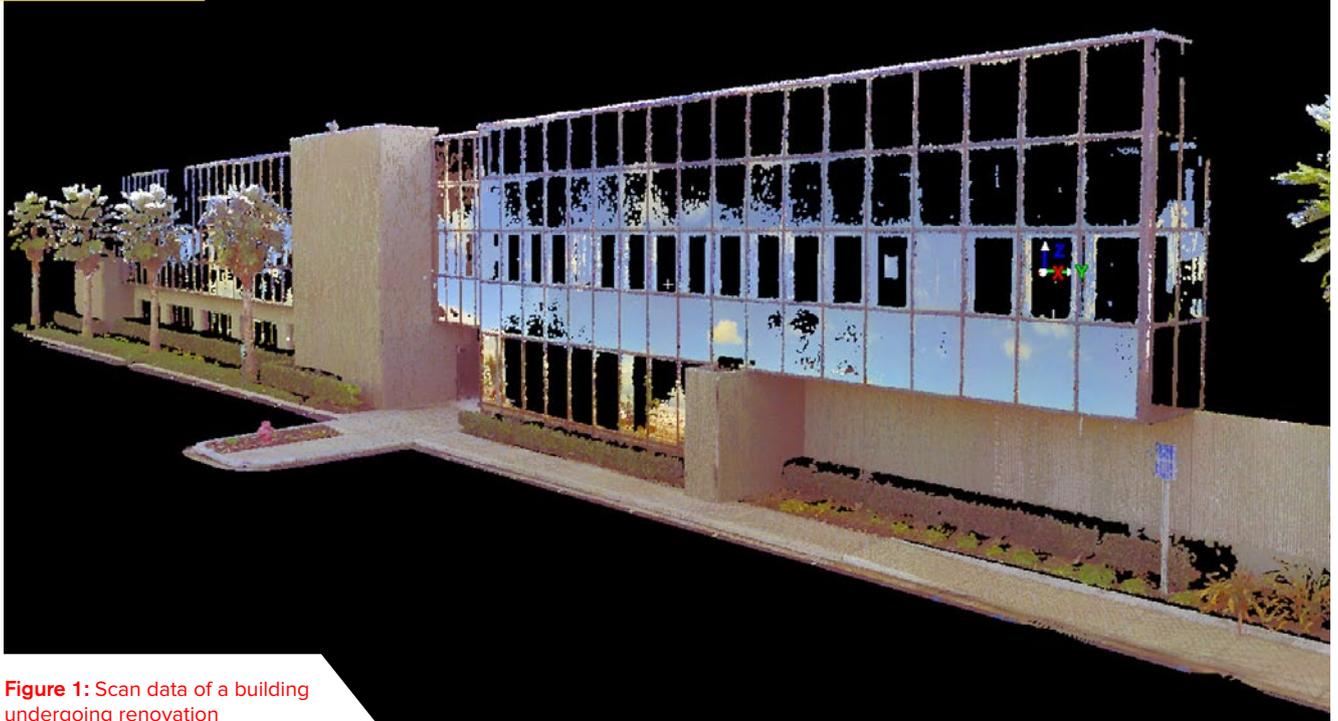
Figure 1: Scan data of a building undergoing renovation

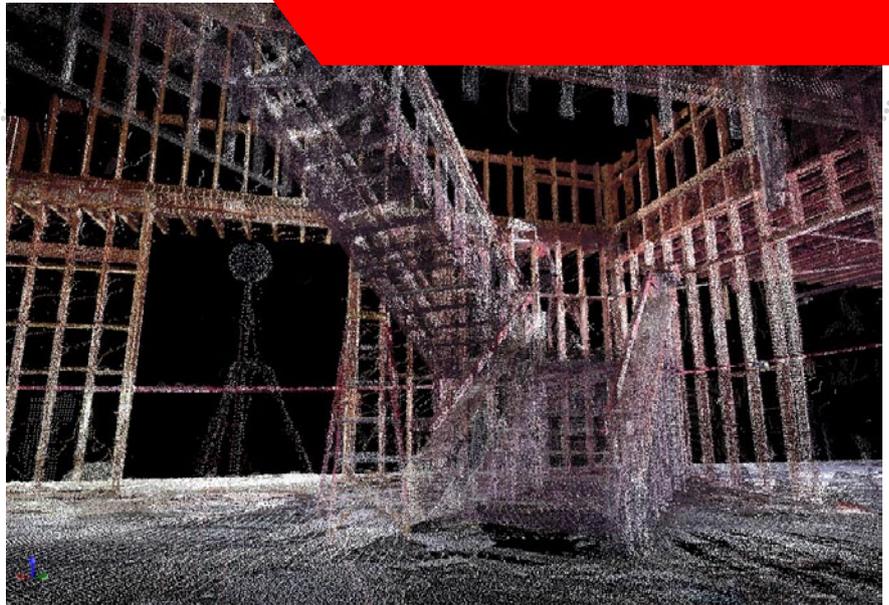
Figure 3: Scan taken after demolition reveals existing conditions of framing systems once concealed

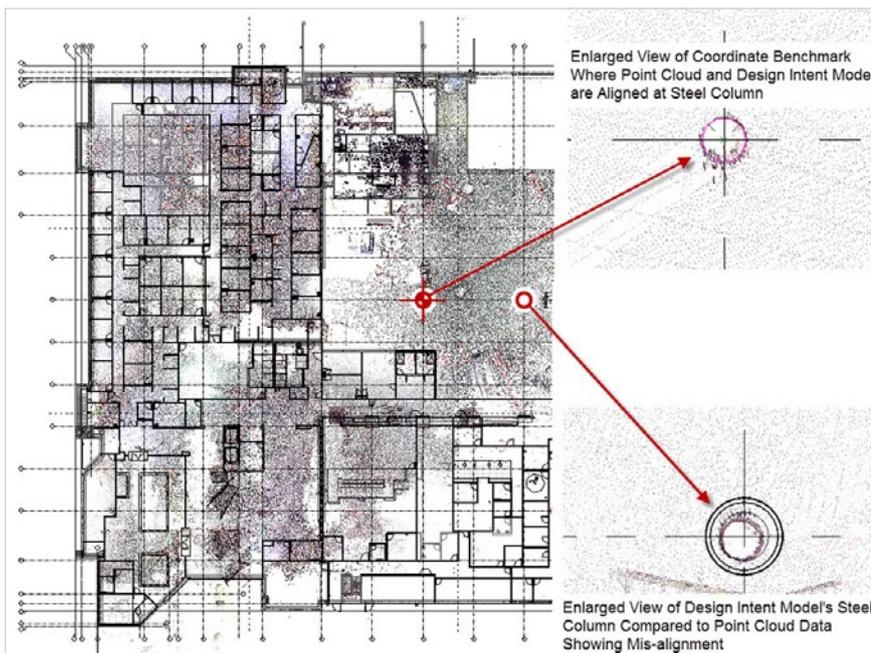
Figure 4: Comparison of scan data and design intent model reveals inaccuracies misalignment of real world steel column

One common problem occurs when the design intent model doesn't match the actual existing conditions. This can occur when the architect relies on inaccurate record drawing information from which to base his/her design. It can

also happen when a poorly executed as-built or field verification is performed. However, some problems are just unavoidable due to concealed unknown conditions that cannot be confirmed until after demolition. Nonetheless, a laser scan performed after demolition can go a long way to identifying conflicts between the design intent model and the actual existing conditions.

It is very common for a designer to begin their design intent model without regard to real world coordinates. Instead, they pick whichever random point they want as their (0,0) benchmark to begin modeling from. Without a real world coordinate, it can be difficult to align the laser scan data with the design intent model. Common features must be identified in both the scan data and the model. Exposed structural columns are often a good place to start. However, anyone who has spent any time working with point cloud data will know that columns are often not in perfect alignment on the column grid. The problem then becomes which column do you align to?

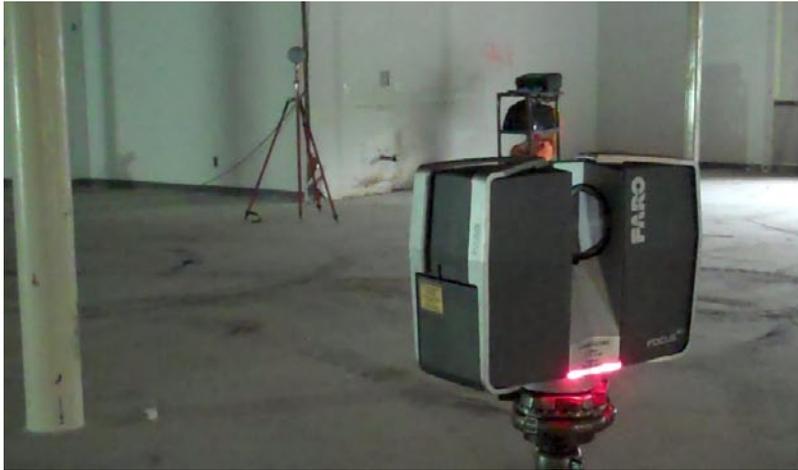
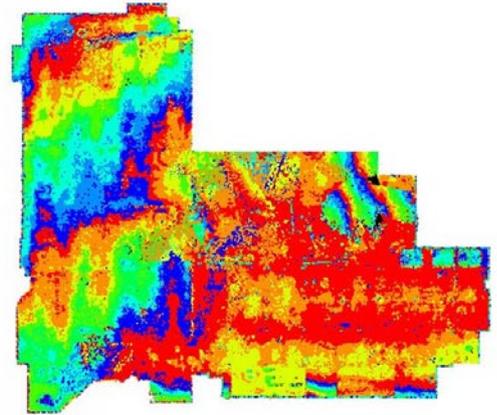
Figure 5: Laser scanner shown acquiring data and resulting image intensity floor map

Floors are often thought to be flat, but are they really? Buildings *do* settle and construction tolerances are not perfect. Many problems encountered in buildings can be identified by verification of a floor's flatness. For example, failing structural members can cause a floor to become out of level. Knowing that a floor is not level can help the project team identify areas of concern for further investigation. Unleveled floors can also make installation of certain floor finishes and floor assemblies fall out of compliance with the specifications. These items are easier to rectify if found early. Laser scanning is an excellent way for contractors to determine floor flatness through the use of an image intensity map of the floor. An image intensity map uses a color spectrum to illustrate elevational differences in the surface of the floor assembly. A physical benchmark can be

set in the field, such as a survey nail, and used to create a point of reference for a grid on both the image intensity map and for layout purposes in the field. Grind and fill areas can then easily be identified and mapped.
