SCANNING SCOTT'S DISCOVERY HUT

BY JAMIE YOUNG

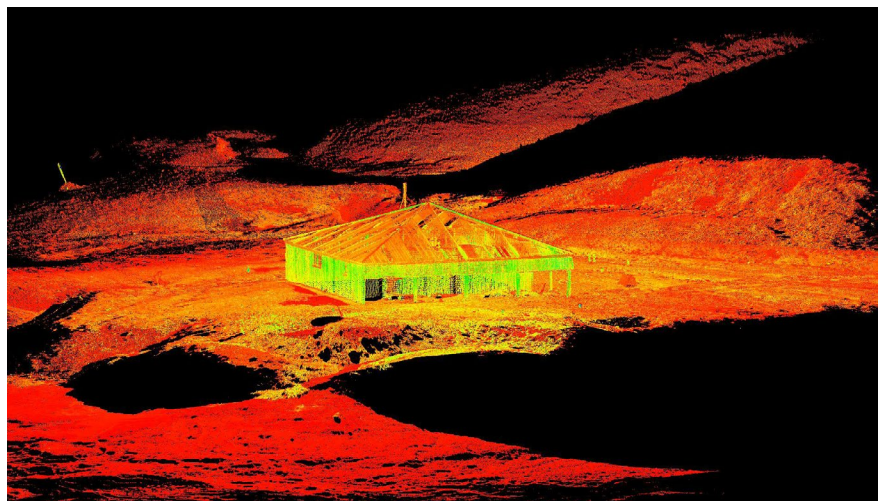
Calibrated exterior scan of Scott's Discovery Hut performed by Erick Mena and Randy Hale of Merrick & Co.
Provided by Erick Mena

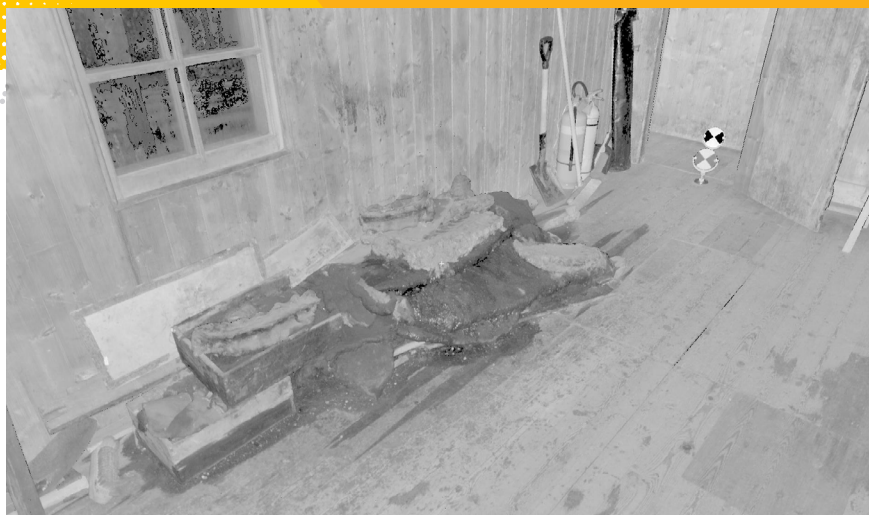
Rendering of scanned data as intensity of preserved seal.

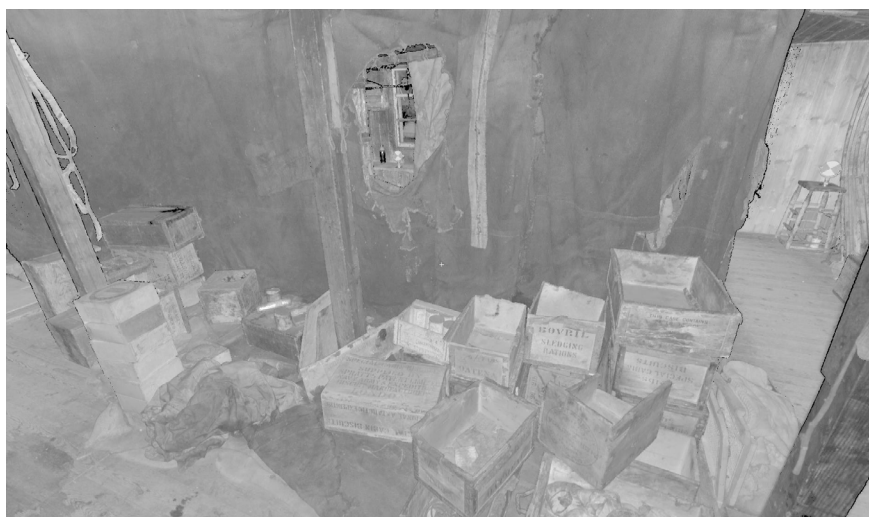
Calibrated scan rendering of some artifacts inside Scott's Discovery Hut.

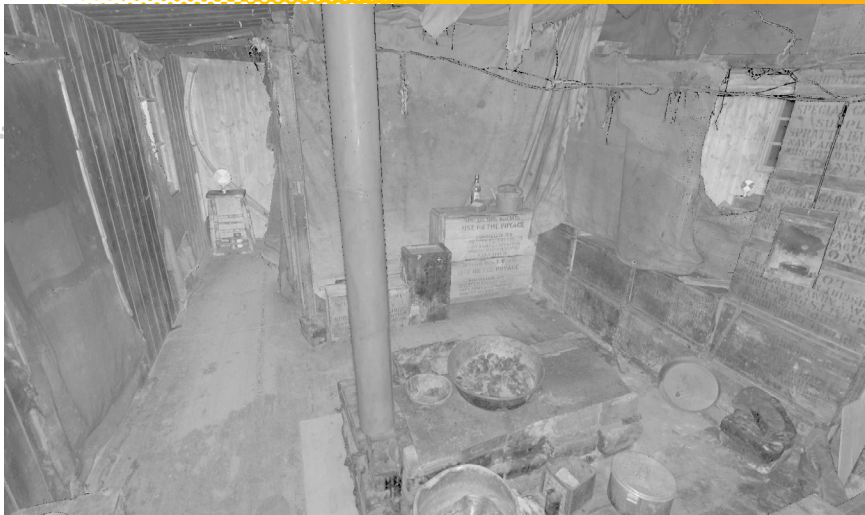
Scan rendering of another part of the inside of the Hut, Note the targets at the end of the hall on the stool and one in the window.

The targets used for the scanning are Leica black and white targets and can be seen in some of the images used in this article. The targets are used to tie together the scans and calibrate the data. The target locations also provided locations for georeferencing the data to real world coordinates. There was a total of 8 targets being used and the targets where moved around for each scan and it was required to have at least 4 targets

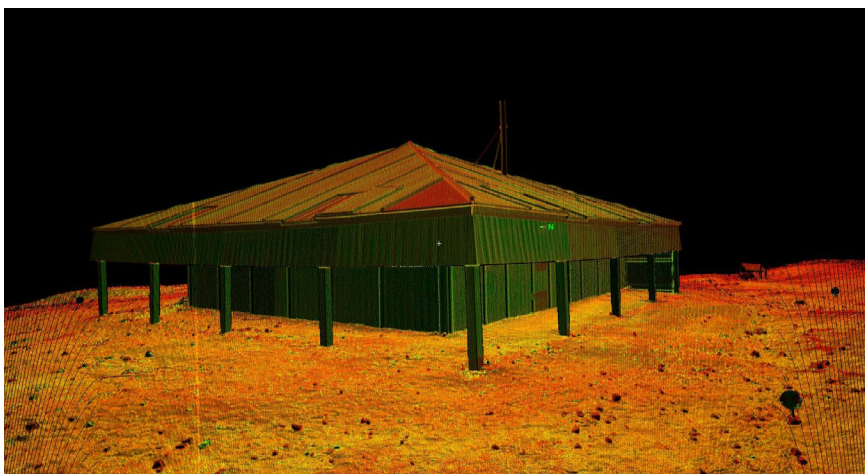
Scan rendering of the exterior of Scott's Discovery Hut.
