# Innovative Strategy for Facility Upgrading

## Hill AFB uses ArcGIS to manage thermal IR imagery

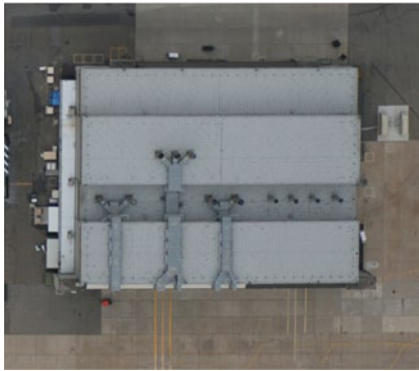
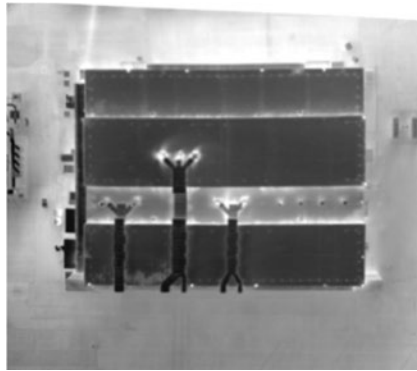
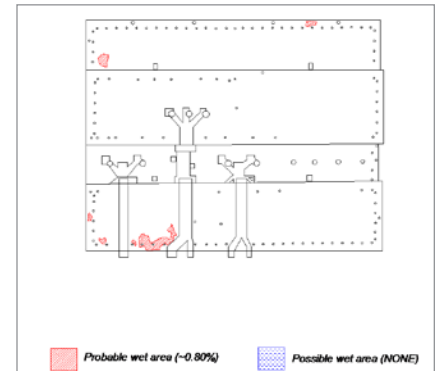
Comparison of standard RGB orthophotography (left) and thermographic imagery (center), which shows areas of water infiltration. Those areas are indicated on the sketch (right).

Thermal IR imagery shows heat and is often presented as a grayscale picture. Shades of gray indicate differences in temperature and emissivity (i.e., the ability to emit energy by radiation) of objects in the image. Typically, objects in a thermal IR image that look lighter are warmer and those that look darker are cooler. Thermographic imagery shows the unique heat signatures produced by different environmental conditions on physical materials. For example, by looking at thermal imagery, it is possible to see how buried chilled-water lines cool the surface above the line.

The wet areas of roof materials have distinctive thermal characteristics. Latent heat, caused by the sun shining on rooftops during the day, is trapped in the water mass of those areas. The heat in those areas is greater than the heat absorbed by dry insulation or roof substrate. As the rooftop cools after sunset,

wet areas of roof insulation and other materials continue radiating heat. That heat can be detected and its signature captured with thermal equipment.
